**SOUTH FORK OF THE EDISTO RIVER AND POND BRANCH
MONITORING RESULTS
(FEBRUARY 2015 TO JANUARY 2017)**

By Alice Walker, Doug Walker, and John Demko

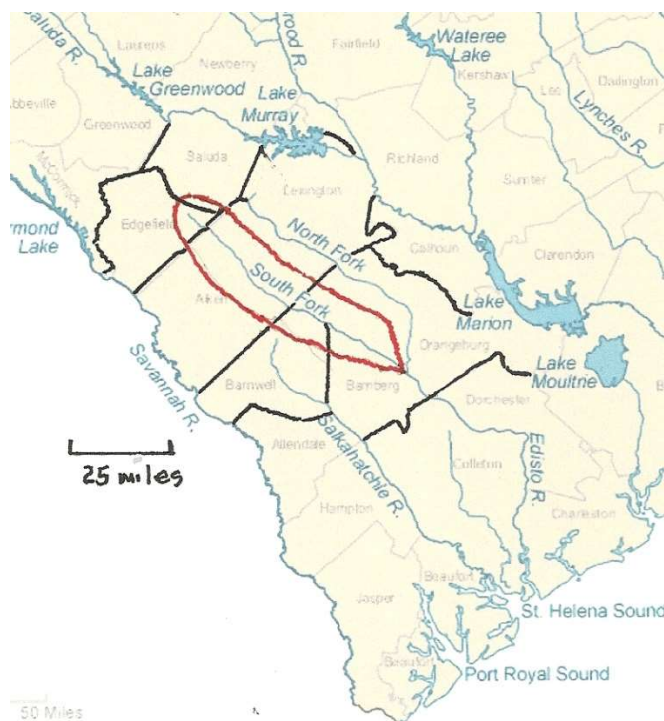
FIGURE 1. The drainage basin for the South Fork of the Edisto River is outlined in red.

The South Fork of the Edisto River drainage basin covers approximately 800 square miles in Saluda, Edgefield, Aiken, Barnwell, Bamberg, and Orangeburg counties (Figure 1.) Most of the watershed is rural and farming is the major land use category. The river supplies water to local farmers and is used for recreational purposes, such as fishing and boating. In January of 2014, public attention focused on the river when South Carolina Department of Health and Environmental Control (SC DHEC) approved an agricultural request from Walther Farms to remove 805 million gallons of surface water per month (later reduced to 400 million gallons/month). Local citizens, both farmers and recreational users, became concerned that the approved withdrawals would adversely affect their use of the river, particularly during times of low rainfall. To address citizens' concerns, SC DHEC held an informational meeting in Aiken, during which they explained that SC state law did not allow them to deny the request. From the discussion, it seemed that little information was available to assess the impact of the water withdrawal. No information was provided on the river monitoring on the South Fork of the Edisto River in the vicinity of the planned withdrawals, except for a few references to the river gauge downstream at Denmark, SC.

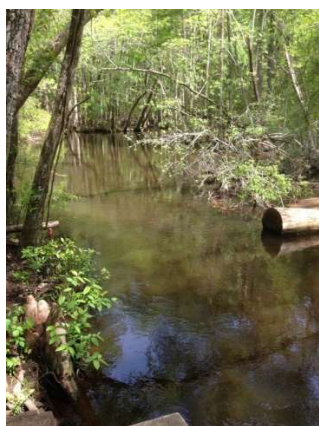
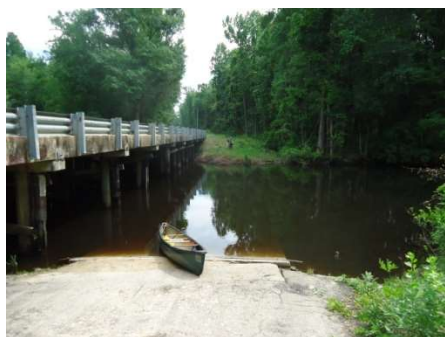
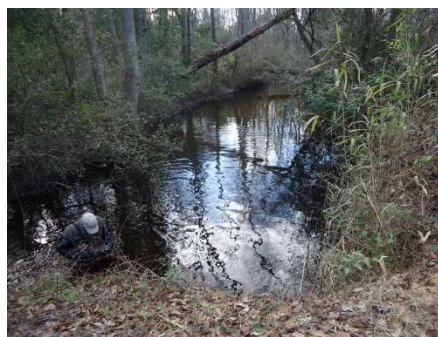
FIGURE 2. Sampling points on the South Edisto River: (a) downstream canoe take-out at Aiken State Park, (b) Keadle Bridge boat ramp, and (c) Pond Branch.

Identifier	Aiken State Park	Keadle Bridge	Pond Branch
GPS coordinates	N 33.5528° W -81.4826°	N 33.5199° W -81.4103°	N 33.5014° W -81.3964°
Location	lower boat landing within Aiken State Natural Area	boat landing at the bridge where S-3-53 (Windsor Road) crosses the South Fork of the Edisto River	culvert entrance where Pond Branch passes under Oak Ridge Club Road
Description	dock on the South Fork of the Edisto River at the canoe takeout within Aiken State Park	boat ramp at Keadle Bridge, approximately 8 miles downriver from the sampling point in Aiken State Park	wooded area about 1.5 mi. south of Keadle Bridge and 0.3 mi. northwest of Davis Bridge
Habitat	mixed hardwood/pine lowland	mixed hardwood/pine lowland	mixed hardwood/pine lowland
GAAS site identifier	S-3296	S-3295	S-3408
Site ID for this report	SER-1	SER-2	PB-1
